REPAIR AND STRENGTHENING OF ASSUMPTION CONVENT LAMNARAI

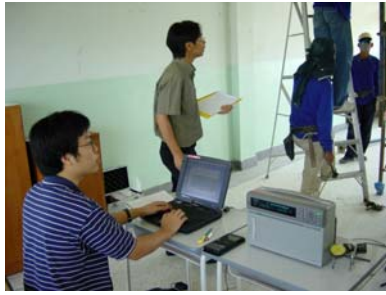
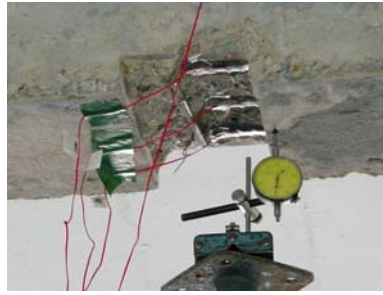
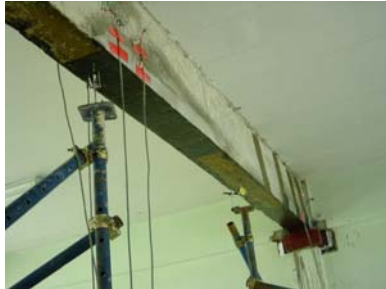
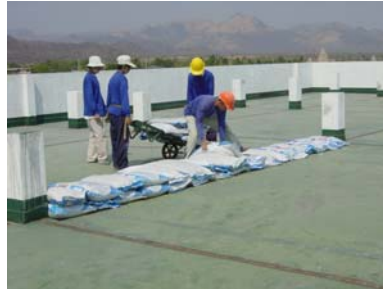
- When covering was removed, it was found that many beams were in poor conditions due to substandard construction. Cavities and cracks could be found in more than 50 beams and 30 of them were in serious condition. Cavities were also found in 20 joints where beams met with columns.

- Cracks in beams would be injected with low viscosity epoxy by using the low pressure injection method.
 - Cracks that significantly effected structural performances of the structure would be repaired by means of stitching with steel rebars and carbon fiber sheets.

- Cavities in beams would be repaired by taking out poor concrete and filling the cavities with high strength grout.
 - Cavities in the joint where column met with beams would be repaired by removing poor concrete and installing steel jacket around top of the column. After that, the cavities would be filled with non-shrink grout.

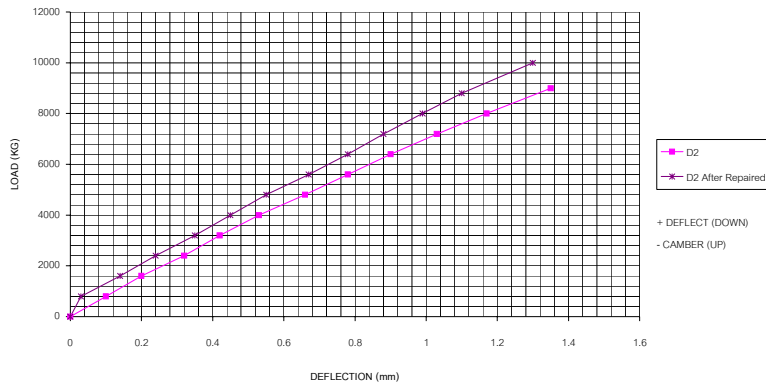
LOAD VS. DEFLECTION - BEAM B234 (LOAD STEP 1)

- Test results
 - Results from the first load test indicated that the beams with defects that had been repaired already were strong and good enough for being strengthened. Stiffness of these beams was much higher than the calculated value. It was also found that composite section was formed between beams and precast slabs.

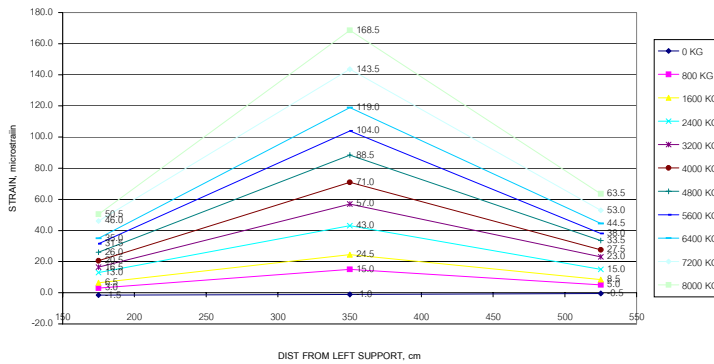
STRAIN DISTRIBUTION (PROFILE) IN CARBON FIBER RODS (BEAM B1) - AFTER REPAIRED

- Variation of strains in carbon fiber sheets and carbon fiber rods under the different test loads indicated bonding between them and the structure and that their function in taking tensile force could be performed efficiently with good stress distribution.
