REPAIR AND STRENGTHENING OF ASSUMPTION CONVENT LAMNARAI

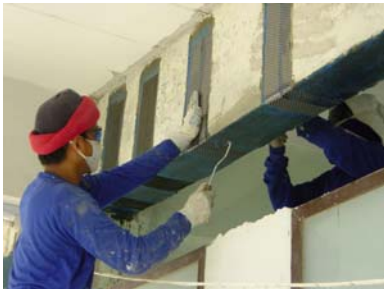
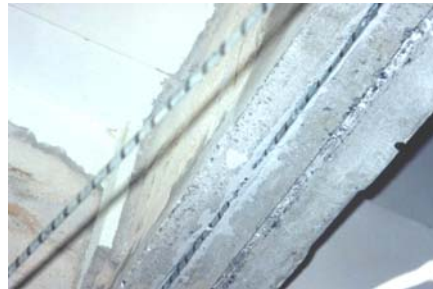
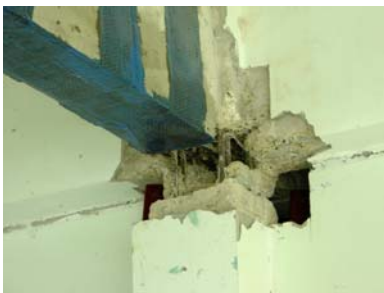
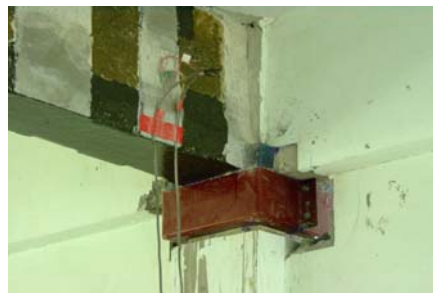
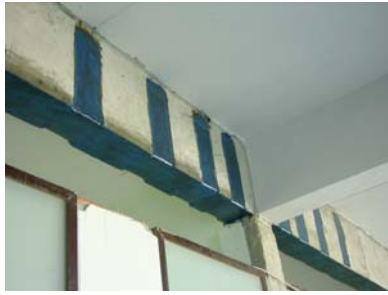
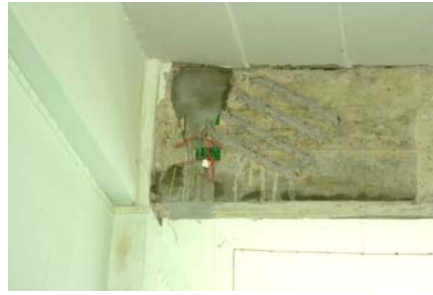
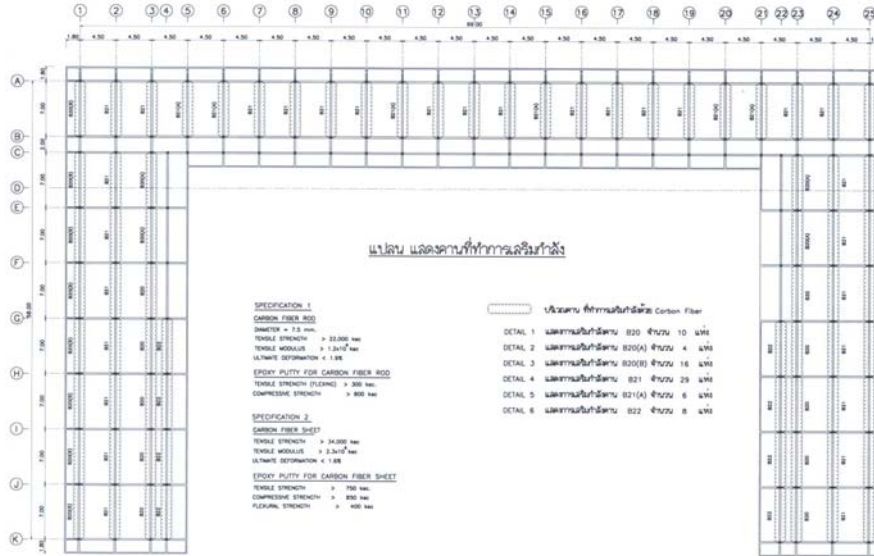
- When covering was removed, it was found that many beams were in poor conditions due to substandard construction. Cavities and cracks could be found in more than 50 beams and 30 of them were in serious condition. Cavities were also found in 20 joints where beams met with columns.

- Repair system selection
 - Carbon fiber composites were selected for beam strengthening to increase flexural strength and shear strength so that they would be enough for carrying the design load without significant changes of members' dimensions. 300 grams per square meter uni-directional carbon fiber sheets were mainly used for this. For the beams having high load carrying capacity, carbon fiber rods were additionally installed at the bottom so that no more than two layers of the carbon fiber sheet would be applied.

- Cracks in beams would be injected with low viscosity epoxy by using the low pressure injection method.
 - Cracks that significantly effected structural performances of the structure would be repaired by means of stitching with steel rebars and carbon fiber sheets.

- Cavities in beams would be repaired by taking out poor concrete and filling the cavities with high strength grout.
 - Cavities in the joint where column met with beams would be repaired by removing poor concrete and installing steel jacket around top of the column. After that, the cavities would be filled with non-shrink grout.
